**Study of Structural Failures Associated with the
Winter 2008-2009 Snow Event in the
Spokane/Coeur d'Alene Area**

December 2009

Structural Engineers Association of Washington (SEAW)

Spokane Chapter

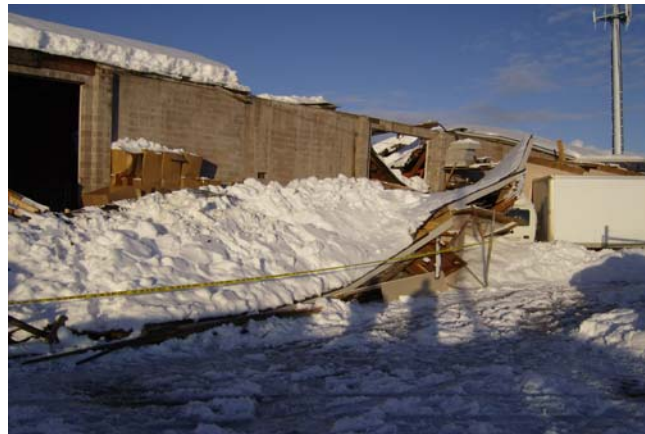
Photo 1: Failed Canopy and Bowstring Truss Roof

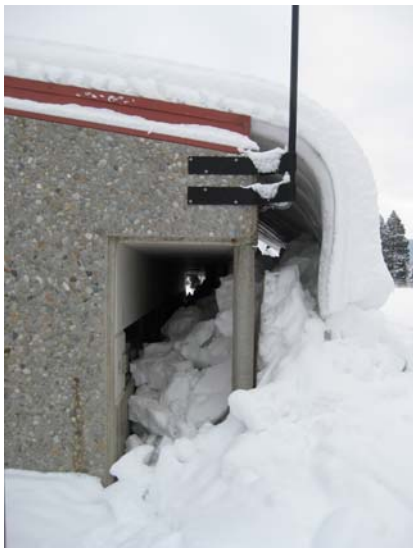
Photo 2: Sliding Snow

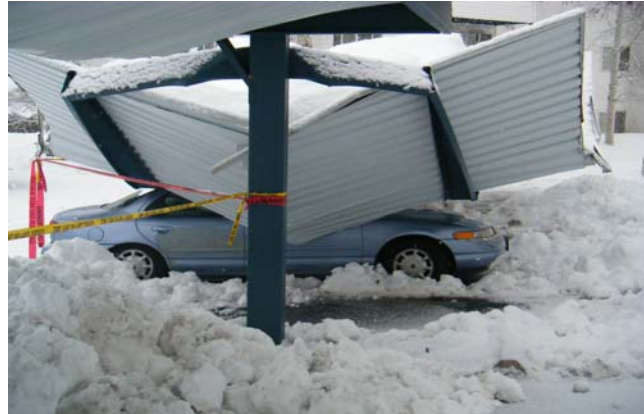
Photo 3: Failed Carport

Metal framed carports with long cantilevered roof decks did not perform well. Proper design, considering unbalanced loads will reduce the number of future failures.

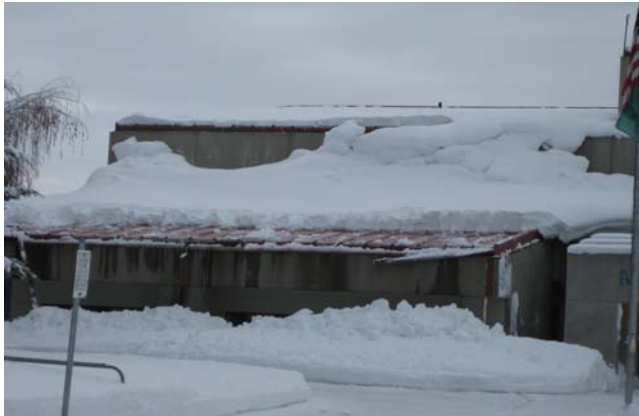
Photo 4: Sliding Snow on Lower Roof

- *Miscellaneous*
Some of the failures observed were due to additions or changes in roof geometry resulting in additional loads due to drifting and sliding snow. Proper evaluation of affected existing structures could reduce the number of structures that perform unsatisfactorily.

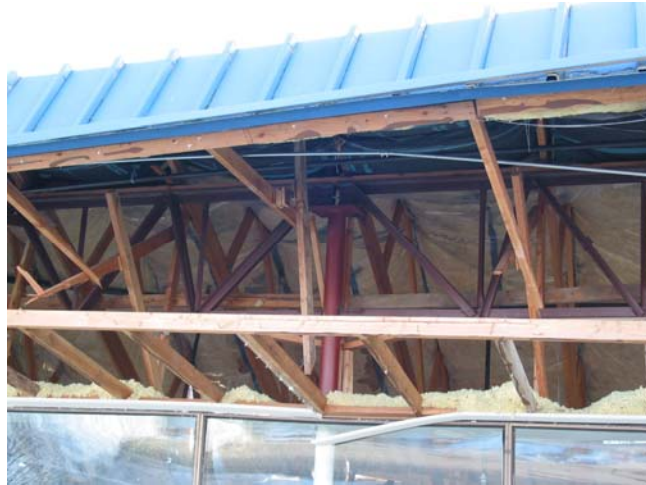
Plate connector wood truss structures represented the single most prevalent system exhibiting failures during the 2008-2009 snow event. The 24 reported failures for this building type constitute 35% of the 68 primary structure failures evaluated. Failures included member fractures and joint failures, as well as lateral buckling type failures resulting from improper installation of stability bracing. At several of the failure sites, it appeared that the failure of a single truss resulted in load being transferred to the adjacent trusses. These trusses then become overloaded and the failure propagated along the roof line. These failures are often sudden and provide occupants with little or no advanced warning to vacate the structure.

Photo 5: Failed Trusses at Retail Building

- *Plate Connector Wood Truss Structures*
Plate connector wood trusses are an efficient and common component of roof structures in contemporary construction. They are typically designed by the truss supplier for prescribed roof snow loads. Bracing of these truss framing systems must also be properly designed and installed. To achieve the design performance required, manufacturing, delivery, installation, and inspection must follow the IBC 2006 and the current Truss Plate Institute recommendations.

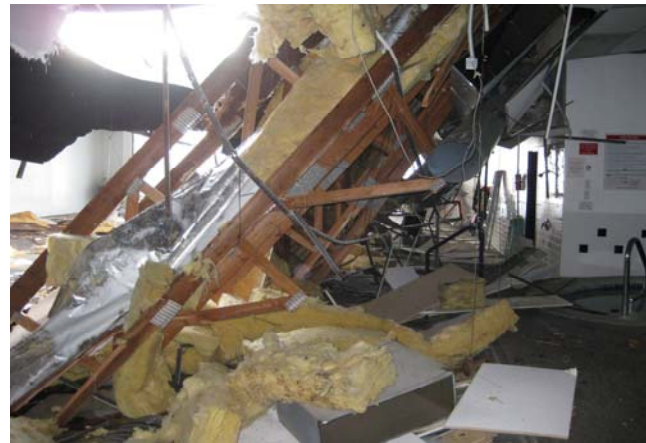
Photo 6: Failed Trusses Over Indoor Pool

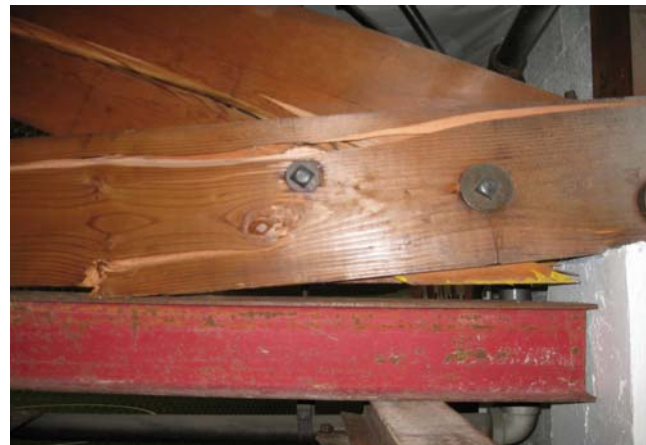
Fifteen (15) failures evaluated were of heavy timber truss construction with sawn-lumber purlins spanning between the trusses. This represents 22% of the primary structure failures observed. Observed failures were primarily caused by broken or split truss members and/or failure of truss connections.

Photo 7: Failed Bowstring Truss Heel Connection

- *Heavy Timber Truss Construction*
The structural design community is aware of the poor historical performance of this type of structure and its potential for sudden collapse. Recent codes have also recognized that unbalanced snow loads can cause stress reversals in web members and have provided design provisions to address this issue. Properly renovated and strengthened, heavy timber trusses can provide safe and stable continued use.

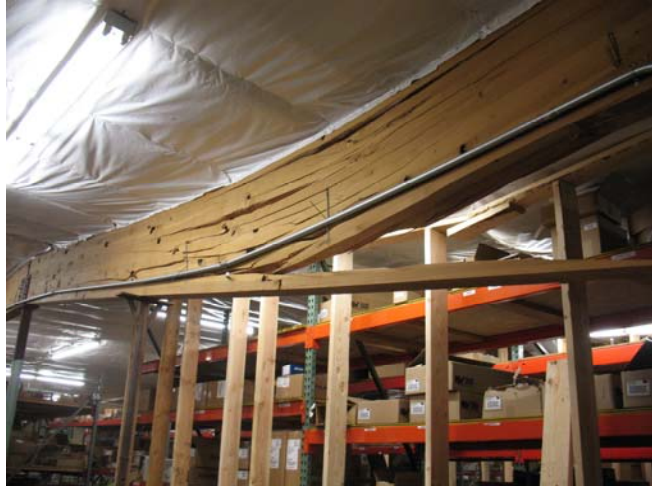
Failures in wood beam and joist framing systems were also a significant portion of the total evaluated. Thirteen (13) such wood framing systems were evaluated representing 19% of the primary structure failures, with a wide variety of configurations and modes of failure. Several appear to have failed due to a single weak point, such as a knot or split in a sawn lumber component, or an inadequate ledger connection.

Photo 8: Failed Glue Laminated Beam

- *Wood Beam and Joist Framing Systems*
The committee recommends that care is taken by the design professional to account for any low-slope areas where ponding could occur.

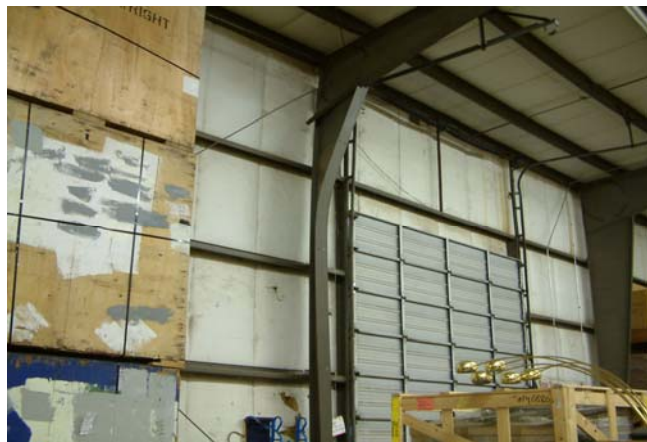
Photo 9: Buckled Column

Pre-engineered steel structures are designed by the supplier. Most often, they employ rigid moment-resisting frames with cold rolled steel roof purlins and wall girts. Bracing of column and beam flanges is often critical in order for the structure to support the design loads. Flange bracing was observed missing on three of the structural failures and had presumably either not been installed or had been removed at some point.

- *Steel Framed Structures*
Of steel framed structures, pre-engineered buildings were the most problematic. Current methods of design, manufacturing, permitting, installation, and inspection should be reviewed. Inadequate bracing resulted in a number of the failures observed during the snow event. Better communication between all parties would result in a better performing structure.

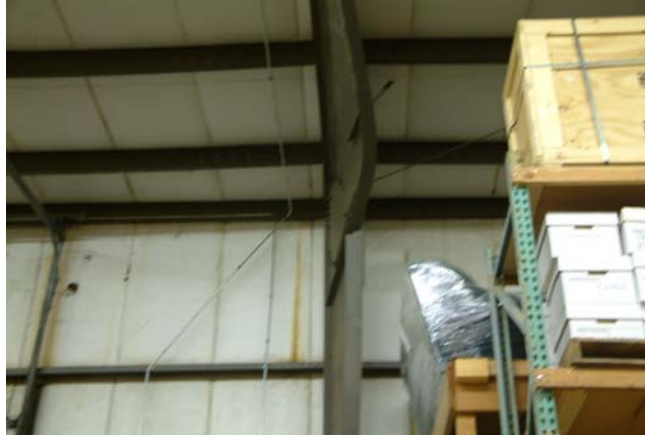
Photo 10: Buckled/Twisted Beam and Column

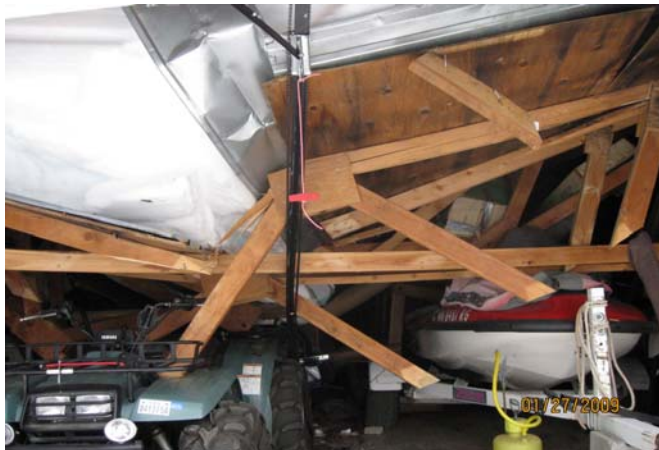
Secondary structures evaluated were of both wood and metal construction. Carports were typically steel framed or aluminum framed; garages most often wood framed. Most of the secondary structures were estimated to be between 30 and 50 years old, although 3 of the carport structures were reported to be only a few years old.

Photo 11: Failed Garage Trusses

- *Secondary Structures*
Many of the failed wood-framed secondary structures observed were likely not designed. Of these structures, most were garages or outbuildings, and most were more than 20 years old. For structures of this nature, not required to be designed by a design professional, proper inspection is paramount to insure that good construction practices are being incorporated.

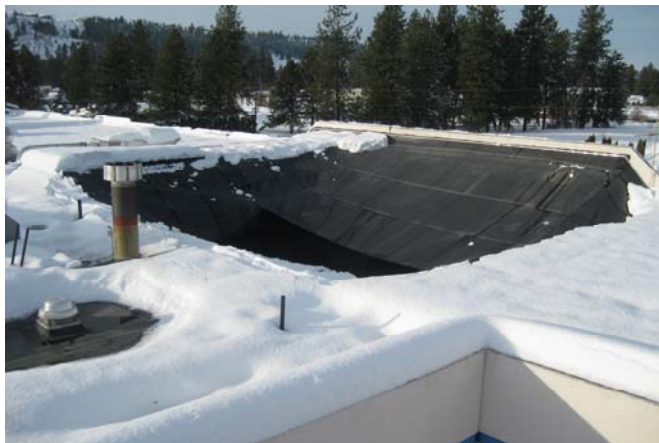
Flat or low-slope roofs (1/4" per foot or less) constituted 47% of the 68 primary structure failures evaluated. The observed failure mechanisms included member overstress, connection failure and ledger failure. Evidence of inadequate drainage was also observed.

Photo 12: Collapsed Low-Slope Roof

the extent that the middle of the joist becomes the low spot, thus collecting water away from a drain. As water collects at this location it results in increased load on the joist, which in turn results in further joist deflection. This increased deflection allows for collection of more water becoming a vicious cycle until the joist becomes overstressed and fails. This phenomenon is known as “ponding” and it is an issue specific to low-slope roofs.
