Hollow-core Floors in Earthquakes: *Assessment and Retrofit*

Ken Elwood

University of Auckland, New Zealand

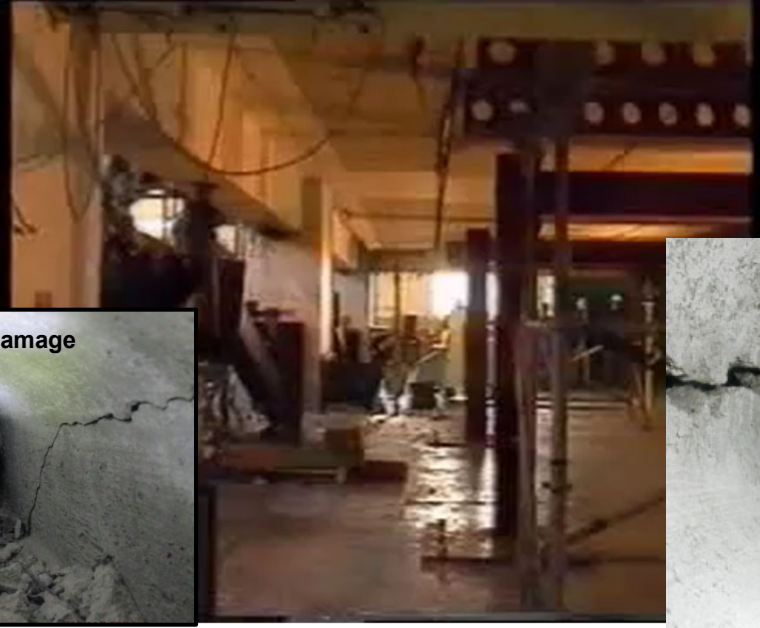
Kaikoura EQ damage

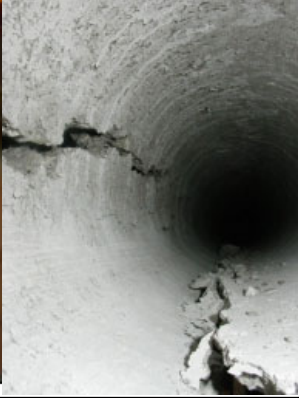
UoC test –
Matthews (2004)
2.5% drift

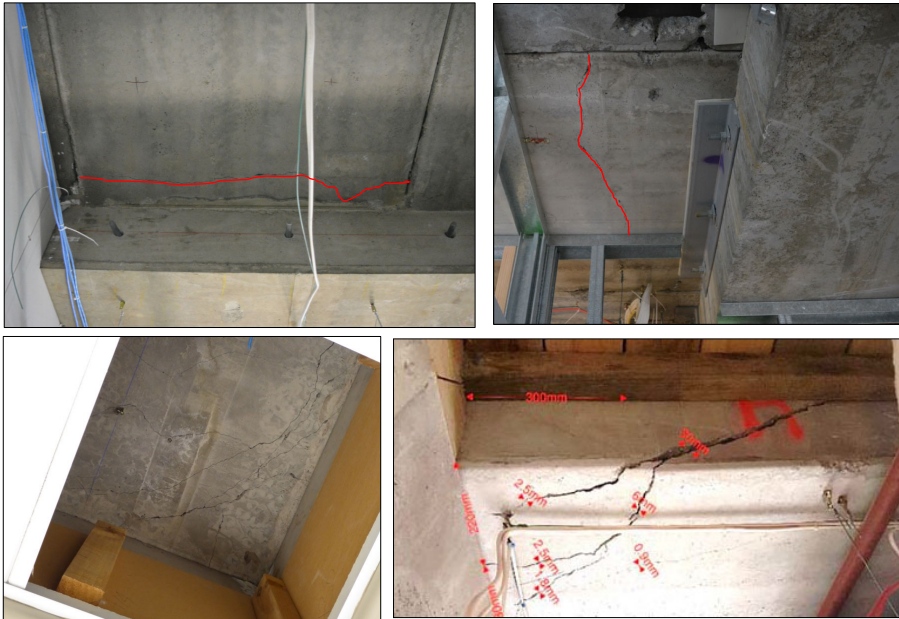
2016 Kaikoura EQ - Hollow-core floor damage

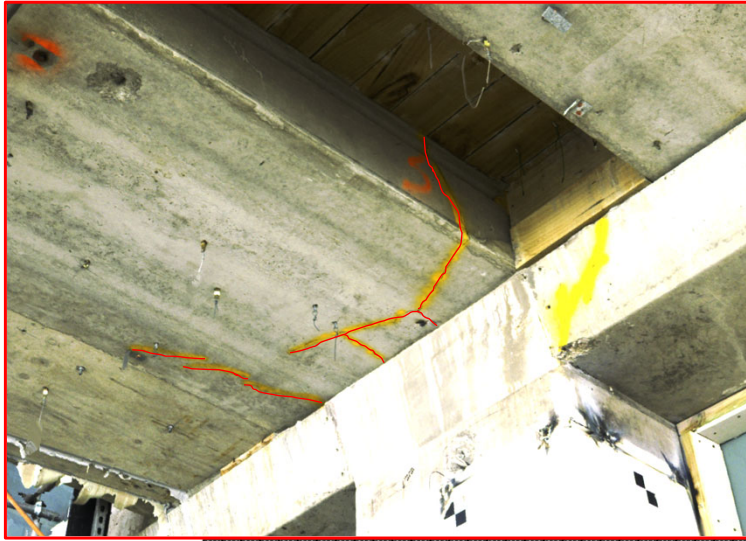
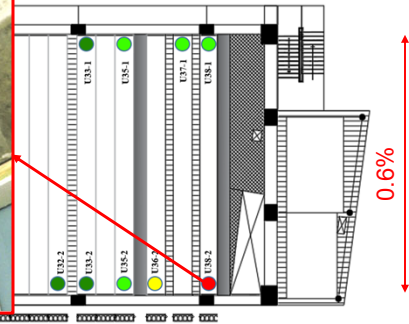
Pier 3-Level 5

1.0%

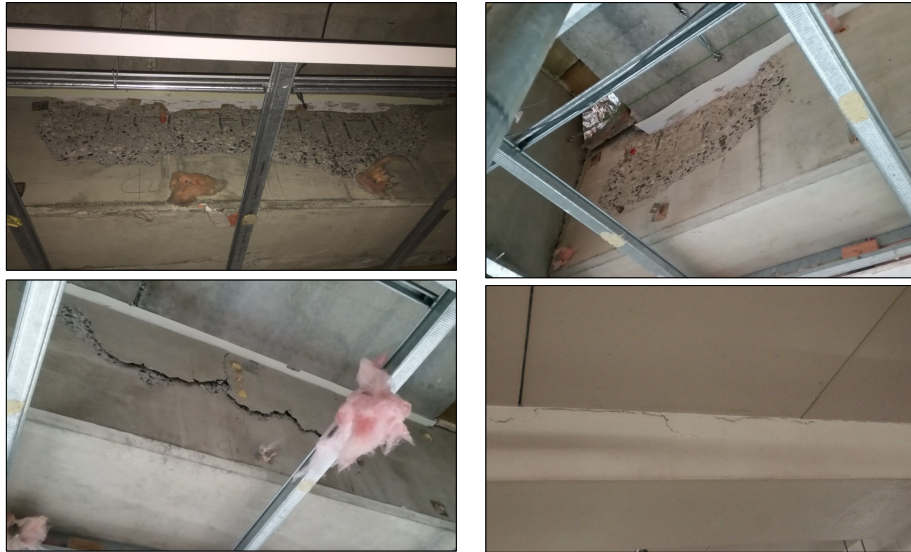
Loss of Seating (LOS) - Spalling

- Kaikoura Earthquake evidence

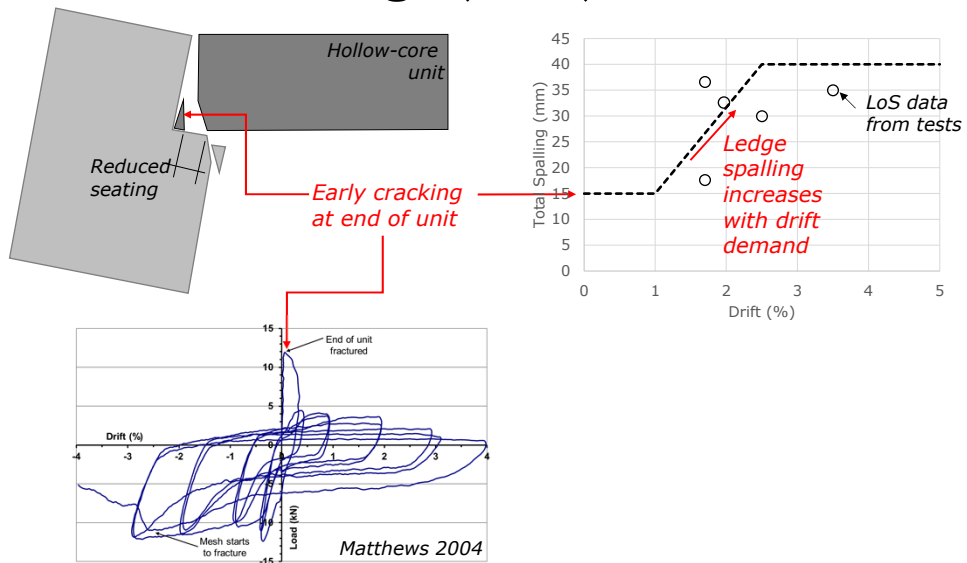
Loss of Seating (LOS)

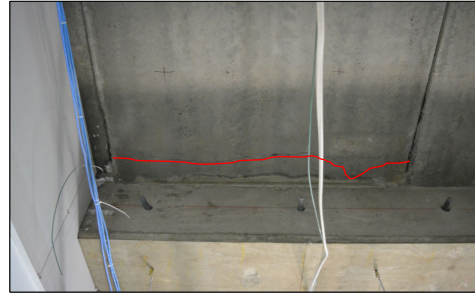
Positive Moment Failure (PMF)

Kaikoura EQ damage

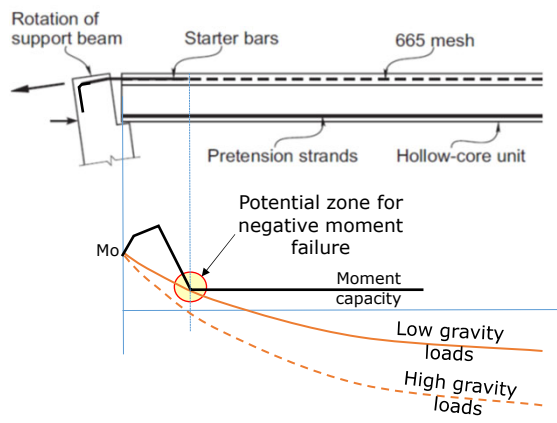
Negative Moment Failure (NMF)

If NMF triggered
→ **Limiting drift = 1%**

- NMF concern for:**
- Low gravity loads
 - Strong or short starters

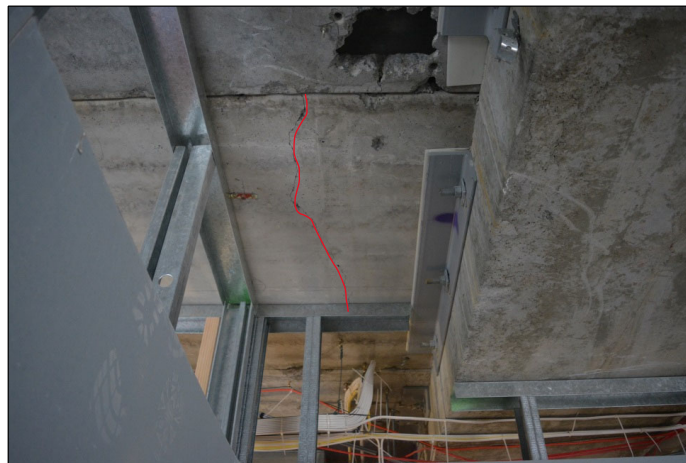
Kaikoura EQ damage

Angle-only retrofits sufficient?

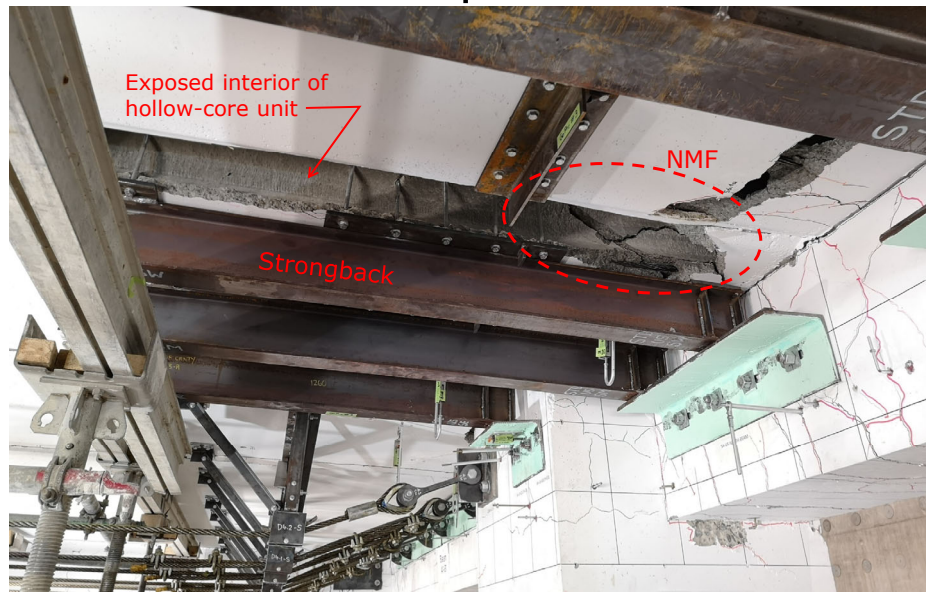
Beta Unit 5 - After Test

Excellent retrofit performance!

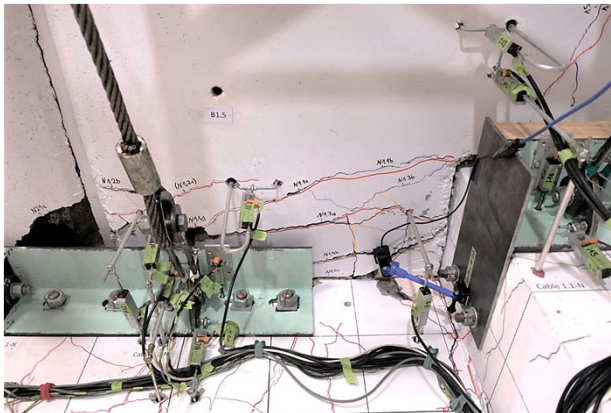
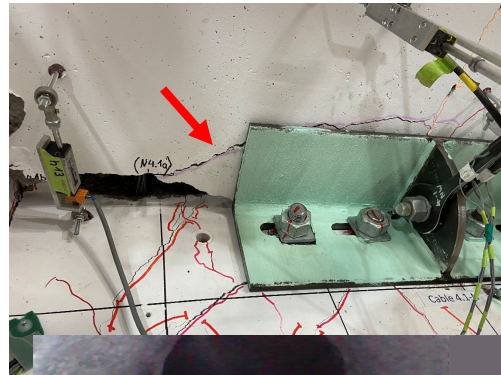
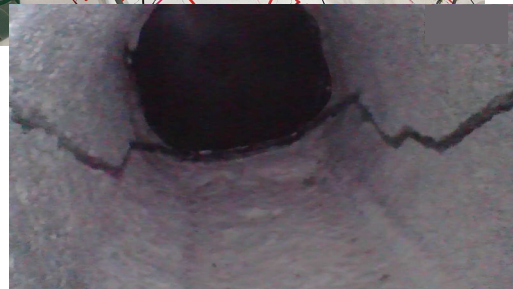
Effectiveness of angle-only retrofits???
