2011 GREAT EAST JAPAN (TOHOKU) EARTHQUAKE & TSUNAMI

Earthquake Reconnaissance **OBSERVATIONS**

JUNE 2011

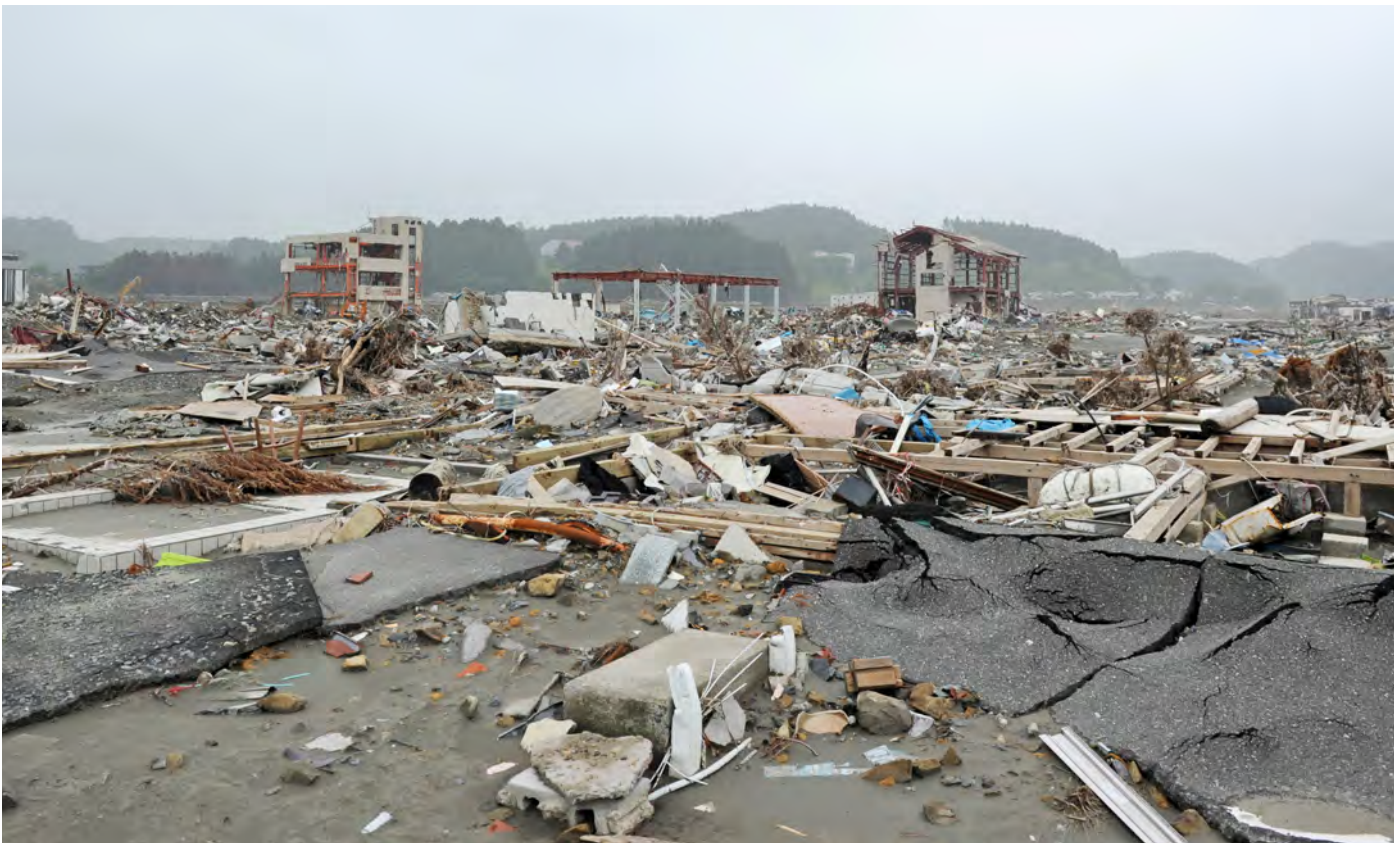
FIGURE 2 - Tsunami Damage in Minami Sauriku, Japan (Swanson)

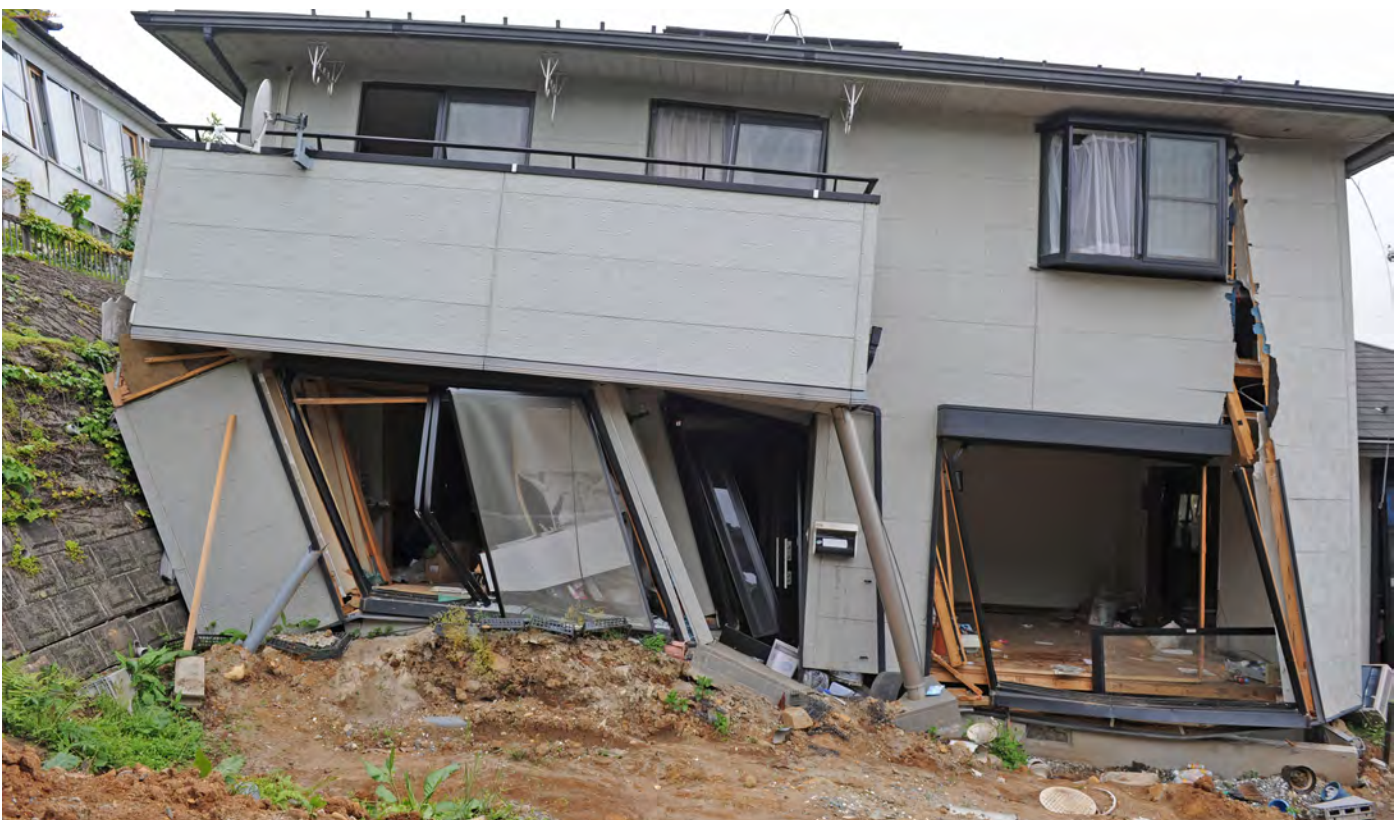
FIGURE 3 - Residential Building Collapse from large areal landslide beneath a residential neighborhood in Sendai City, Aoba Ward (Swanson)

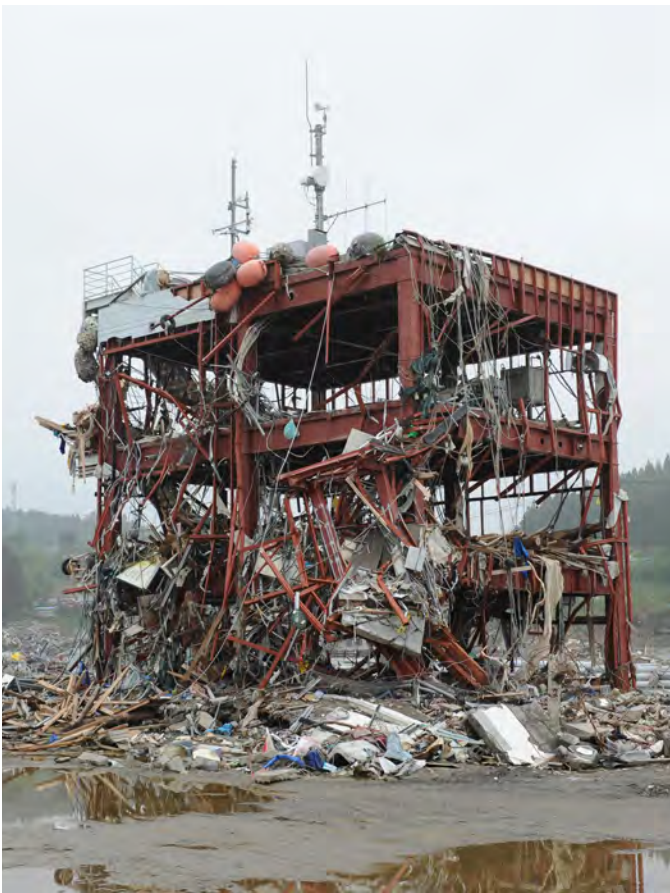
FIGURE 4 - Modern Disaster Prevention Center building in Minami Sauriku after the 14m tsunami (Swanson)

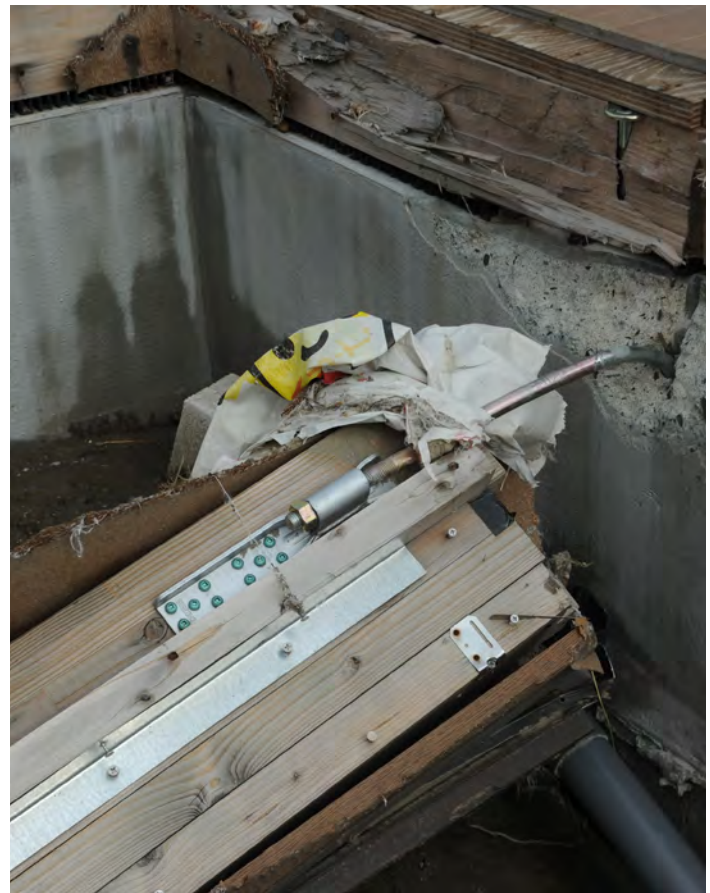
FIGURE 5 - Bent Wood-framed Shear Wall Hold-Down Connection from Tsunami (Swanson)

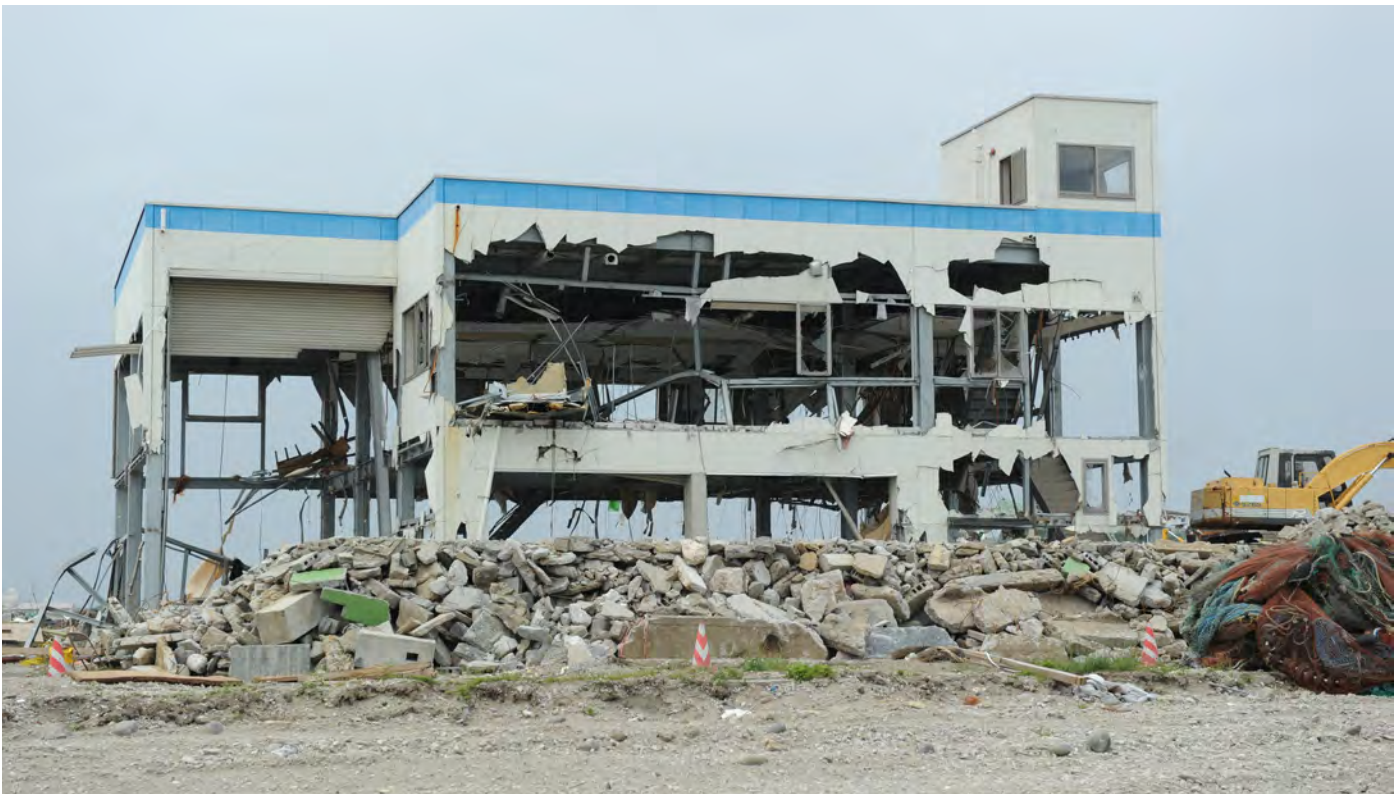
FIGURE 6 - Tsunami Damaged Steel Moment Frame Building in Natori from 7m Tsunami Height (Swanson)

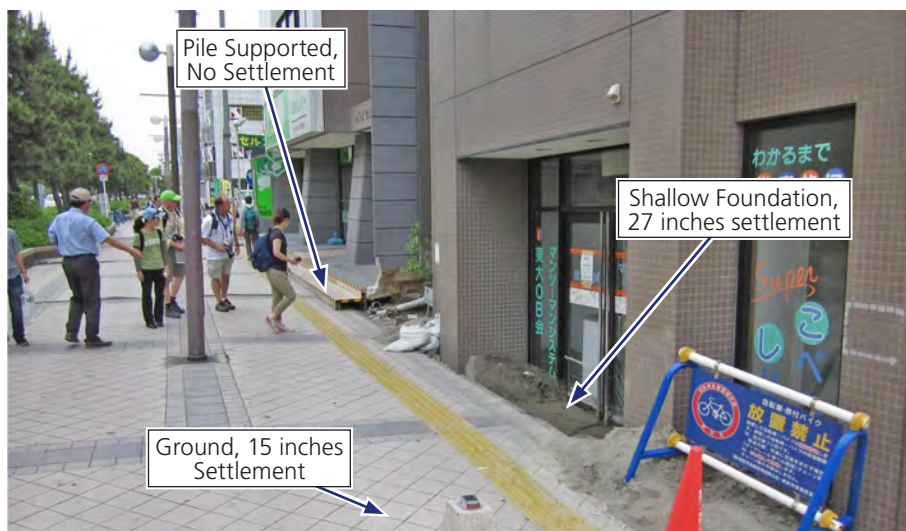
FIGURE 8 - Performance difference between adjacent buildings supported on piles versus shallow foundations in Urayasu City (Lindquist)

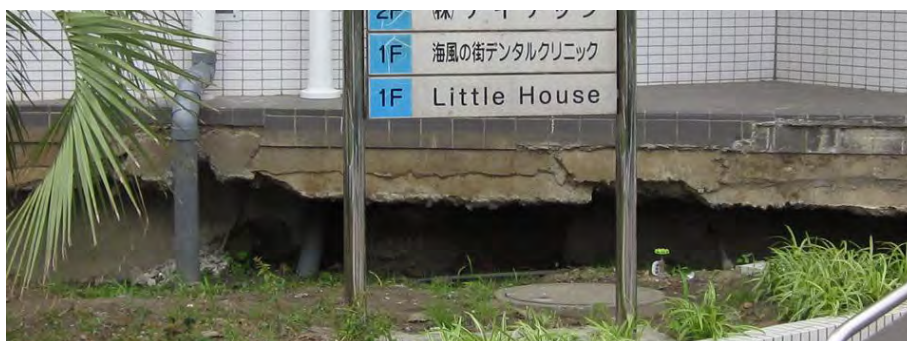
FIGURE 9 - Temporary utility connection following settlement caused by liquefaction in Urayasu City (Lindquist)

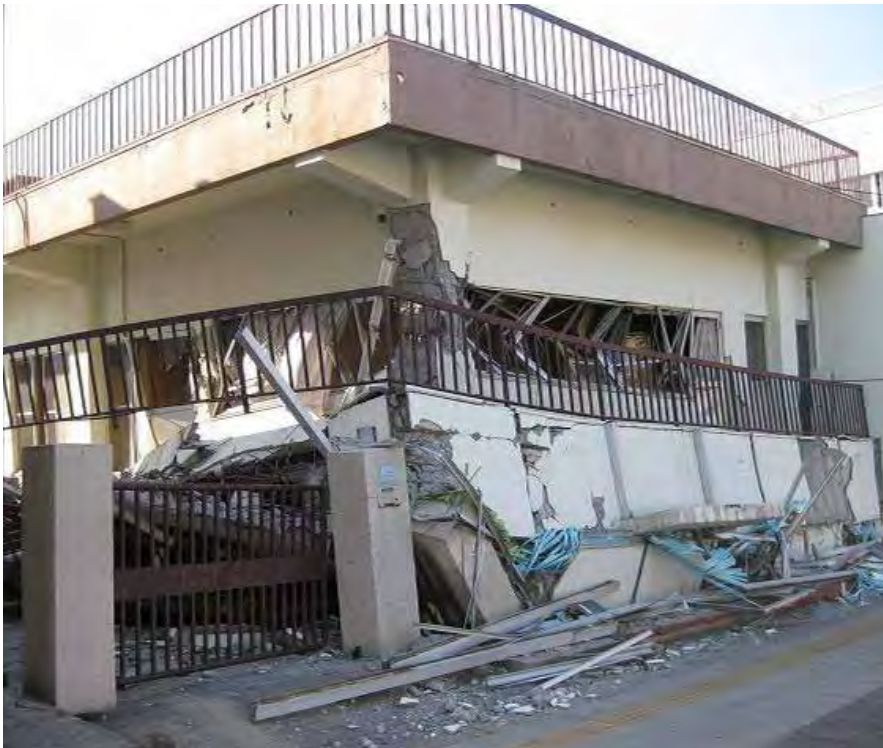
FIGURE 10 - Non-ductile concrete frame-over shear wall building. First-story walls failed in out-of-plane direction, Second-story columns failed in shear. (image courtesy of Motosaka)

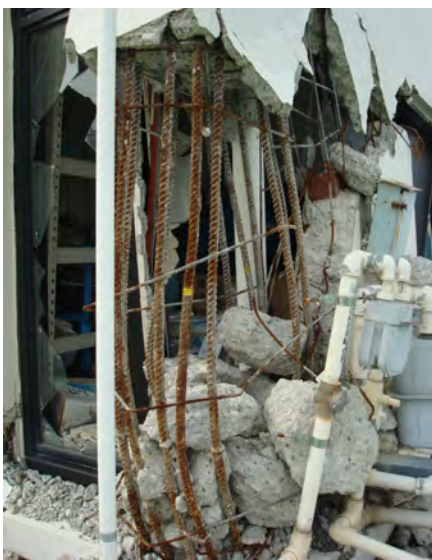
FIGURE 11 - Non-ductile shear wall boundary member detailing at a penthouse on top of a nine-story concrete building with a two-story podium. (Siu)

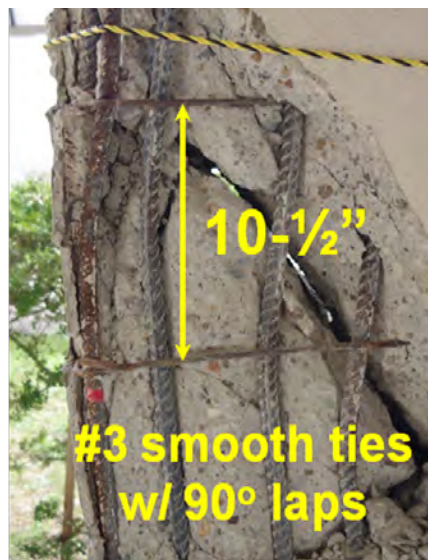
FIGURE 12 - Non-ductile concrete column detailing at the first story of a two-story building located in an area with potential topographic effects. (Siu)

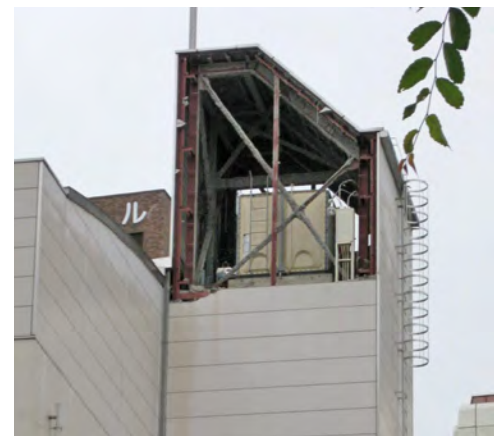
FIGURE 14 - Cladding damage at a school in Sendai. (Siu)

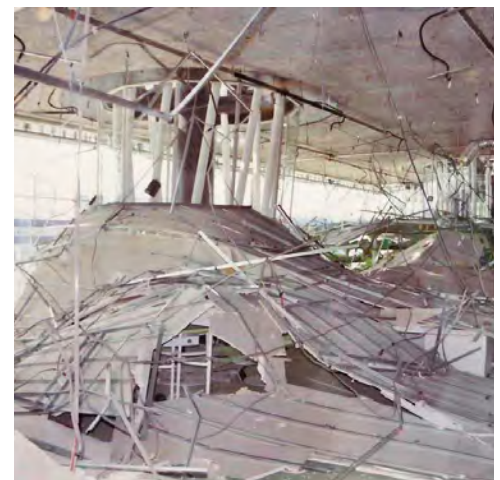
FIGURE 15 - Unbraced suspended ceiling collapse at the Sendai Mediatheque. (Siu)

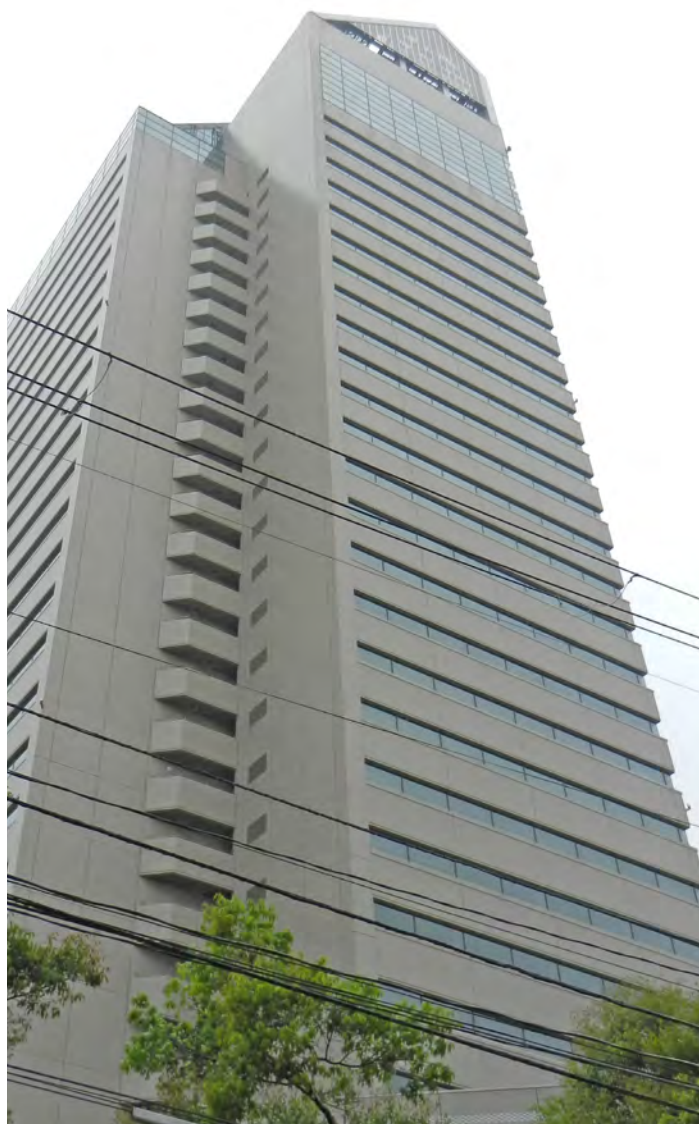
FIGURE 16 - High-rise building in Sendai. No structural damage was reported, but businesses and equipment on the top floors were damaged. (Taylor)

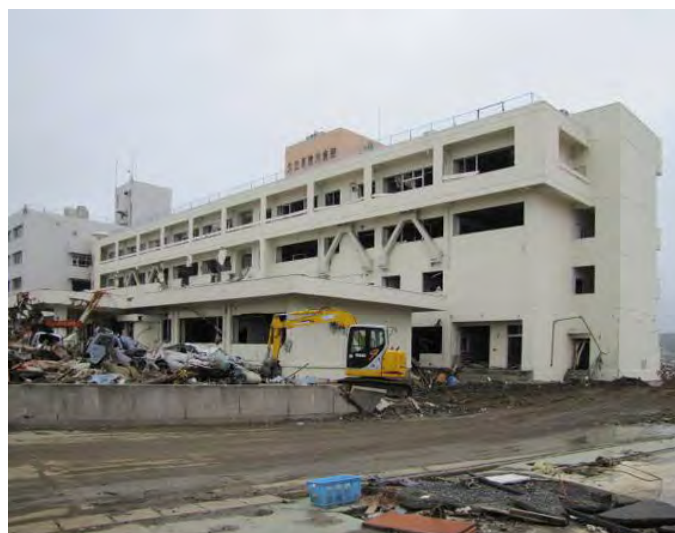
FIGURE 23 - Retrofitted hospital in Minamisanriku Town survived the ground shaking and provided shelter from 15m tsunami. (Pierepiekarz)

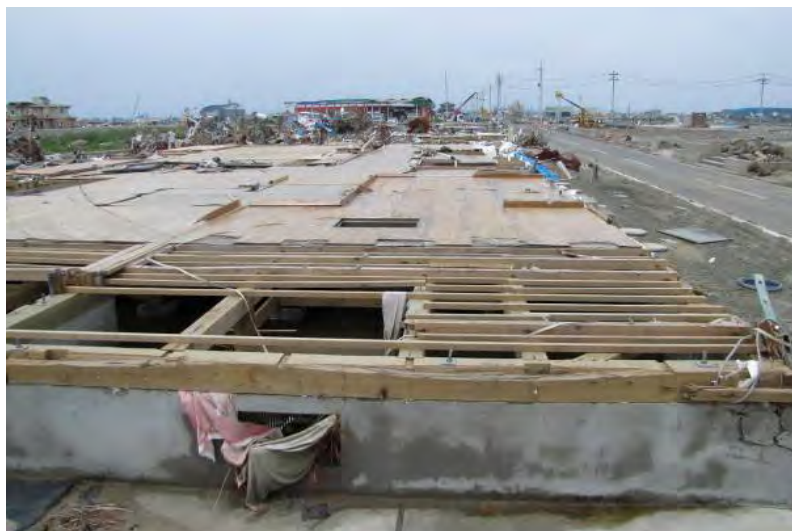
FIGURE 24 - Destroyed wood-framed buildings in Arahama Ward (Sendai). (Pierepiekarz)

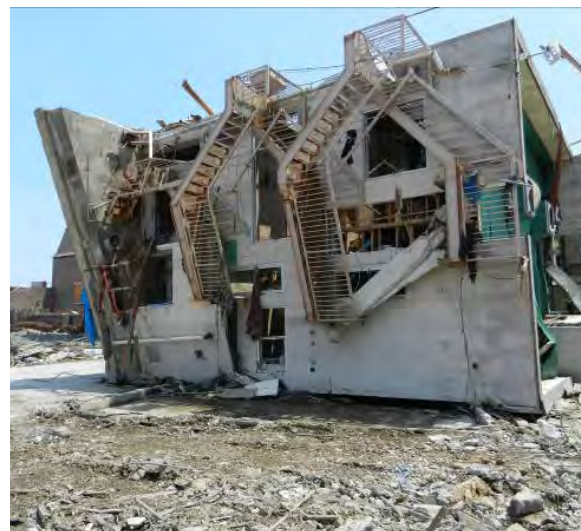
FIGURE 25 - Overturned steel-framed structure in Onagawa City. (Taylor)

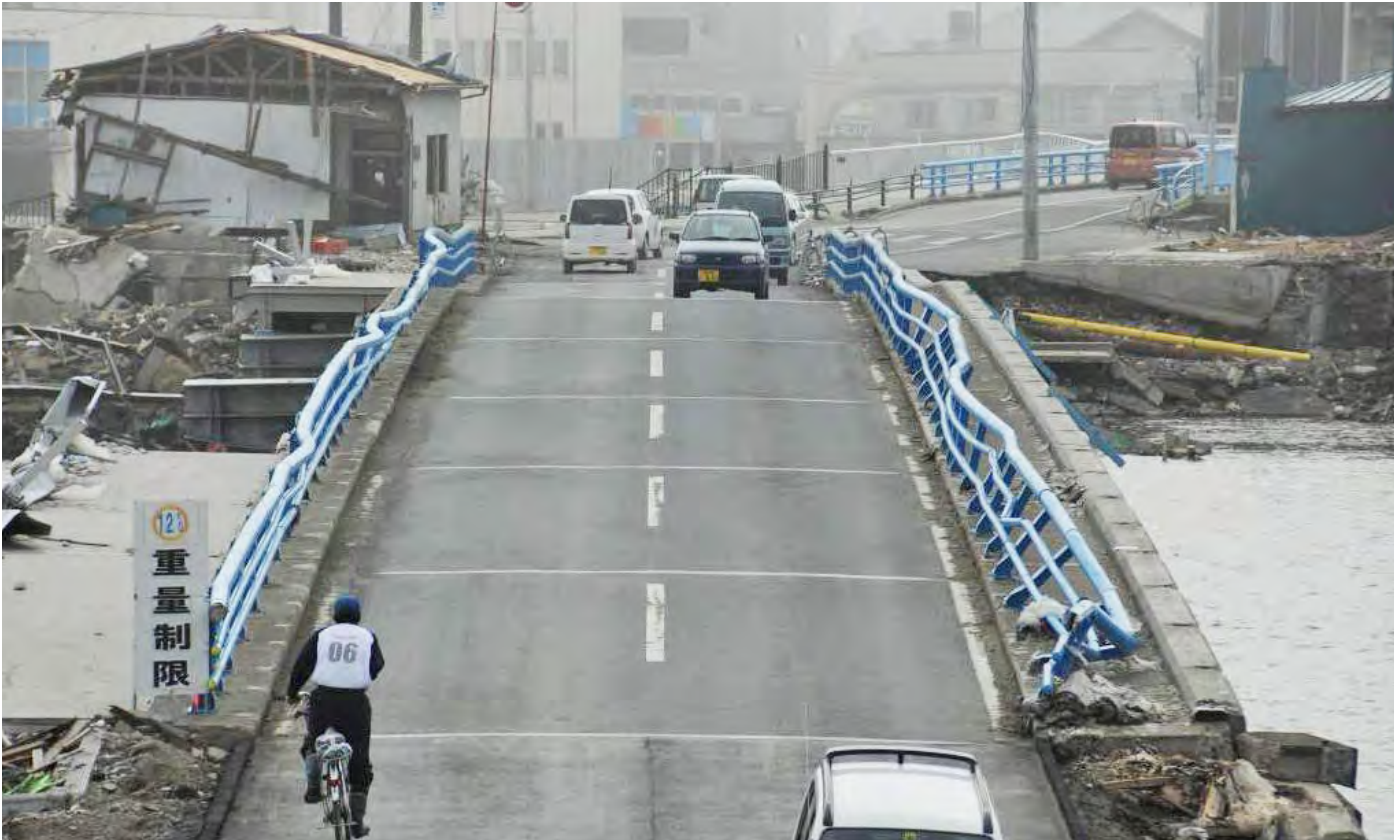
FIGURE 26 - Functional Low-Profile Vehicle Bridge In Ishinomaki City. Note Damage from Tsunami to Leading Edge of Bridge Walkway and Guardrail on the left side of the photo. (Swanson)

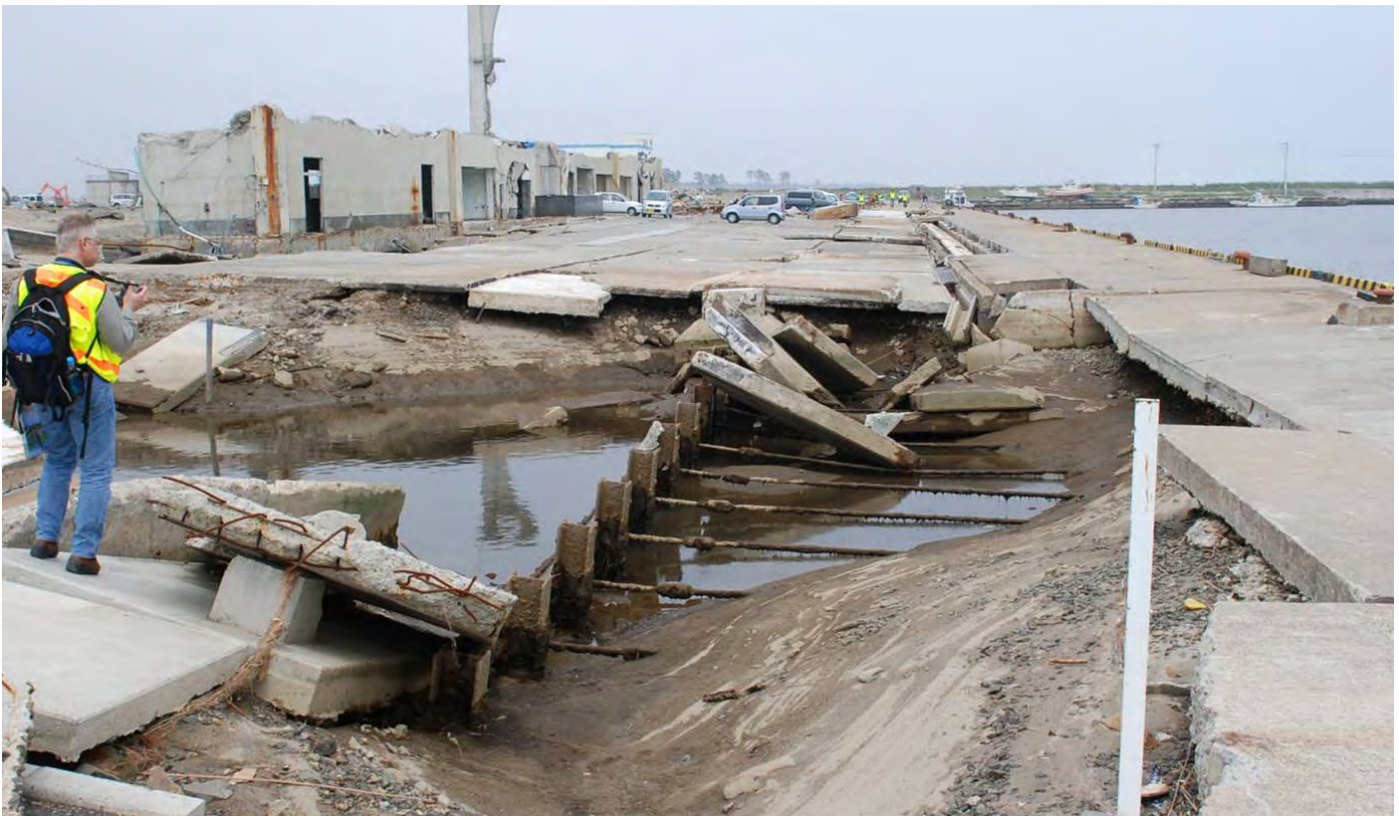
FIGURE 27 - Waterfront Tsunami Scour Behind Seawall in Yuriage. Note Exposed Seawall Tiebacks. (Swanson)

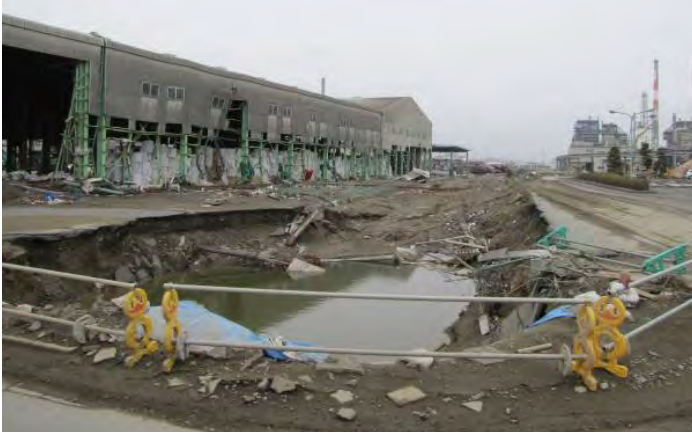
FIGURE 28 - Ishinomaki City – tsunami impacts to warehouses and infrastructure. (Pierepiekarz)

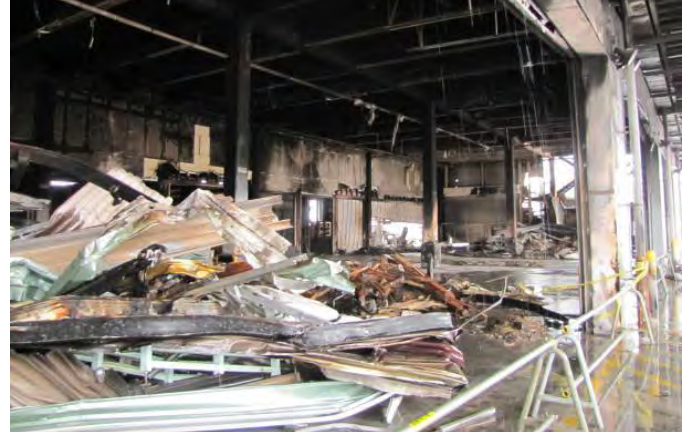
FIGURE 29 - Fire-following-earthquake impacts at Sendai Airport cargo area. (Pierepiekarz)

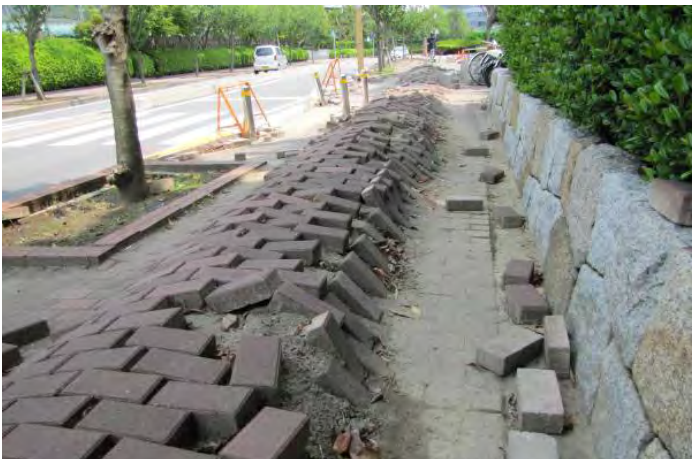
FIGURE 30 - Underground utility impacts (soil liquefaction) in Chiba (Tokyo metro) area. (Pierepiekarz)

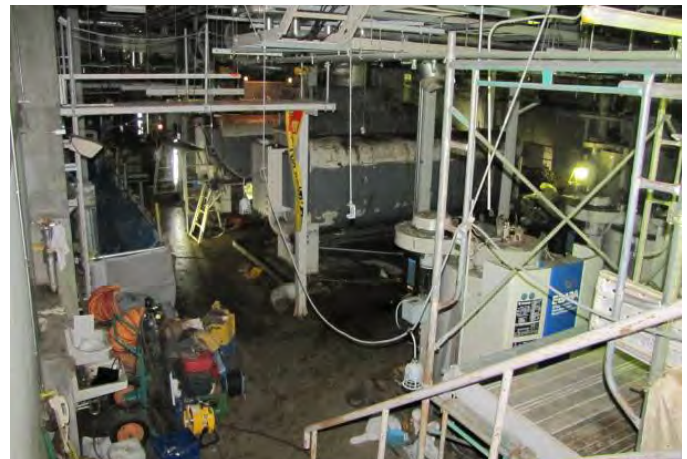
FIGURE 31 - Sendai Airport – main utility room located below grade was flooded. (Pierepiekarz)

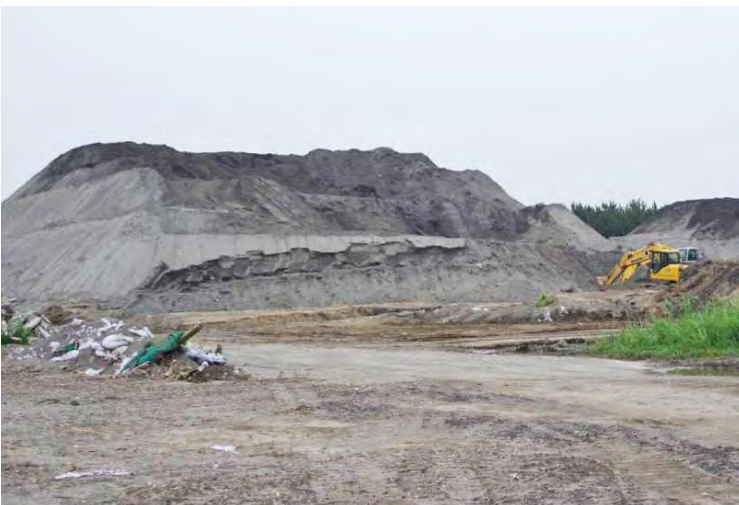
FIGURE 37 - One of three mountains of liquefaction sand in Urayasu City. Liquefaction ejecta totaled over 80,000 m³. (Siu)
