THE NISQUALLY EARTHQUAKE OF 28 FEBRUARY 2001

PRELIMINARY RECONNAISSANCE REPORT

Nisqually Earthquake Clearinghouse Group

March 2001

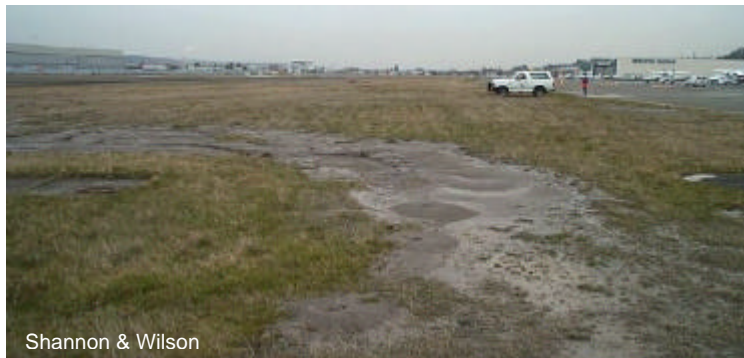
Extensive liquefaction was observed in localized areas. At the King County Airport (Boeing Field), which lies within the Duwamish River corridor south of downtown Seattle, extensive liquefaction was seen along the eastern runway where zones of ejecta covered areas some 300 ft long (Fig. 3.3). Ground surface settlements of up to 9 inches were observed in this area. A few

Figure 3.3: Sand boils at King County Airport

scattered sand boils were observed along the western runway of the airport, but a 4 ft wide, 6 ft deep sinkhole was reported at the north end of the western runway. Apparent ground oscillation caused the opening of cracks in pavement joints along both runways. Along the west edge of the western runway, a longitudinal crack, approximately 1000 ft. long and 1/2-inch to 1-inch wide was observed. The pattern of sand boils and areas of pavement cracking appear to correspond to an old meander of the Duwamish River. The southern half of the western runway (which was not in the area of the old river meander) appeared to be unaffected by ground shaking or liquefaction.

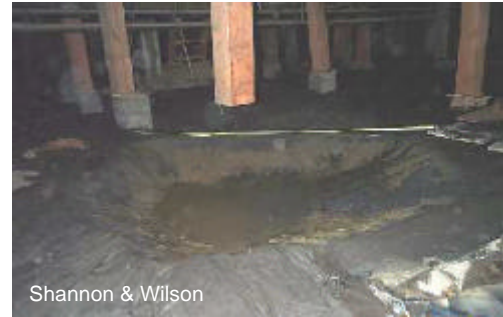
area known as the Sodo District. Because of the flat topography of these areas, little evidence of consistent lateral deformation was observed. A number of structures in the Sodo area were extensively damaged by liquefaction-induced foundation failure; an example, in which some pile caps have separated from the columns and settled approximately 4 ft (out of sight), is shown in Fig. 3.4.

Figure 3.4: Settlement of pile cap in liquefied soil beneath industrial building south of downtown Seattle.

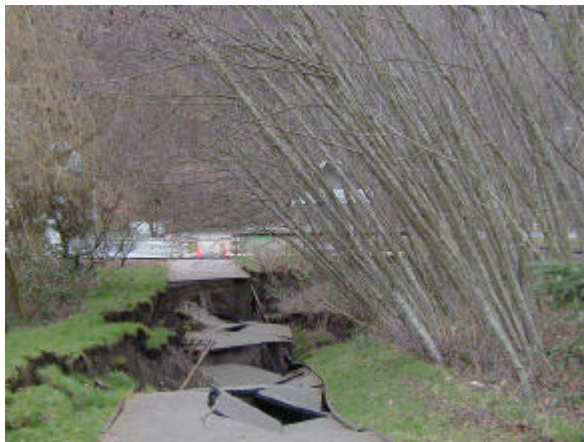
Lateral spreading was observed at a number of sites in the Olympia/Tumwater area. Several lateral spreads were observed along the banks of Capitol Lake south of downtown Olympia (Fig. 3.5). Capitol Lake was the site of similar lateral spreads in the 1949 and 1965 earthquakes. These spreads produced lateral displacements ranging from a few inches to several feet, and affected nearby roads, footpaths, railroads, and utilities. Lateral spreading at the

Figure 3.5: Lateral spreading at Capitol Lake

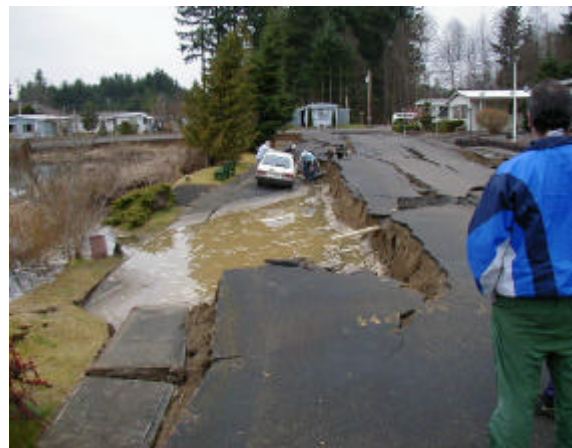
Figure 3.6: Lateral spreading at Sunset Lake trailer park in Tumwater.

Sunset Lake mobile home park removed a portion of roadway and damaged utilities and trailer foundation slabs.

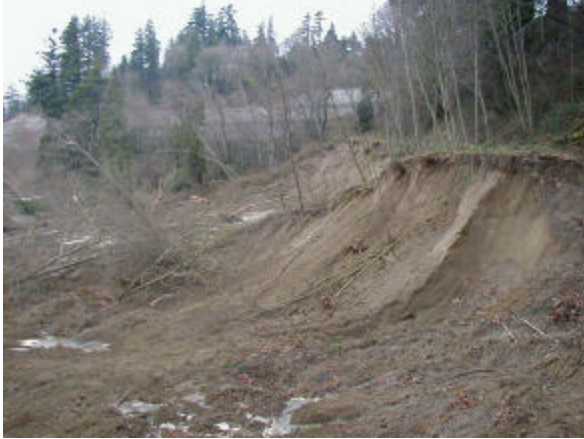
A number of landslides were observed within the Puget Sound Basin. Many of these slides occurred in natural materials, such as the 400 ft long slide on the northeast side of Capitol Lake (Fig. 3.7). Other slides occurred in engineered fills, particularly at locations where they spanned low-lying areas of natural soils (Fig. 3.8). A flow slide removed part

Figure 3.7: Landslide at Capitol Lake in Olympia.

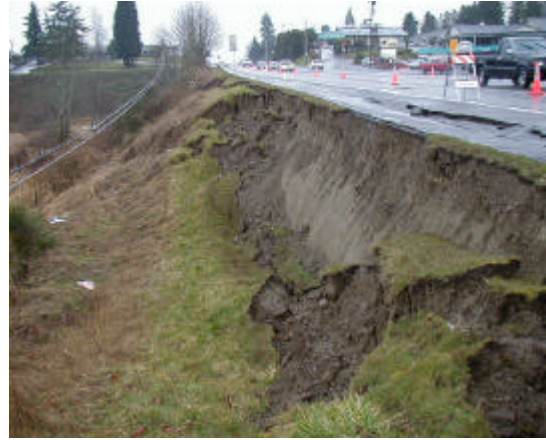
Figure 3.8: Landslide along Martin Way in Olympia.

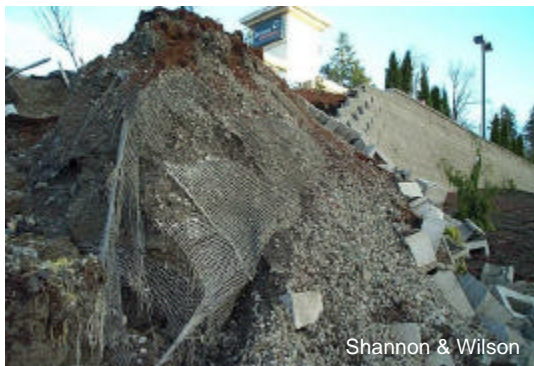
Some damage to earth structures was observed. A mechanically stabilized earth (MSE) wall supporting a hotel parking lot in Tumwater failed following the earthquake, however, the question of whether a broken water pipe at the top of the slope was a cause or a consequence of the wall failure has not yet been answered.

Figure 3.9: Failure of MSE wall in Tumwater.

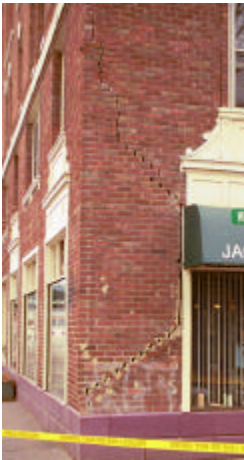
Figure 4.1: Wall Cracking - Olympian Apartments

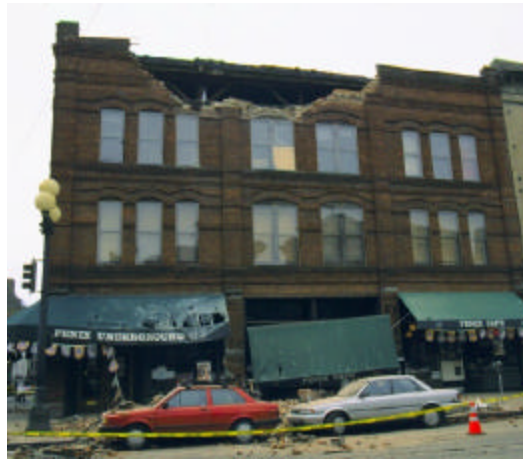
Unreinforced masonry (URM) buildings built before 1950 exhibited the poorest behavior. The most common damage included shedding of brick from parapets and chimneys. Other URM buildings exhibited diagonal “stair-step” cracking in walls and piers (Figure 4.1), damage to walls in the upper stories (Figure 4.2), vertical cracking in walls, damage to masonry arches, and damage to walls as a result of pounding (Figure 4.3). In many cases, fallen brick resulted in damage to objects, such as cars and canopies, outside the building (e.g. Figure 4.2).

Figure 4.2: Brick Parapet and Wall Failure - Fenix Cafe

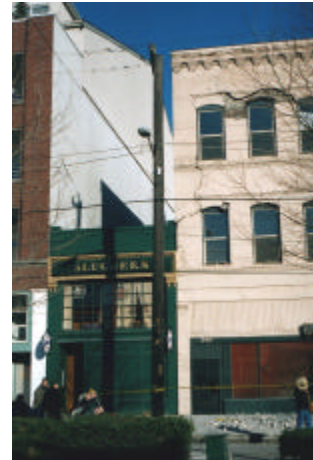
Figure 4.3: Pounding Damage

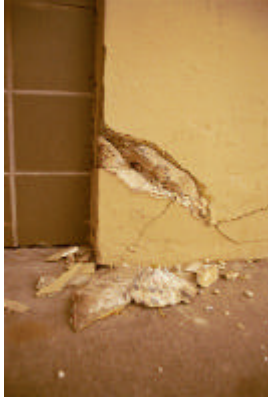
Figure 4.4: Concrete Spalling in RC Column

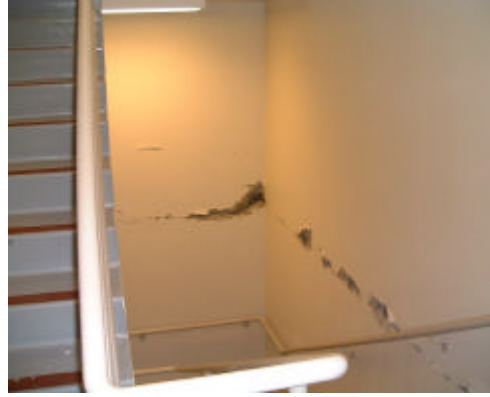
Figure 4.5: Damage at Construction Joint

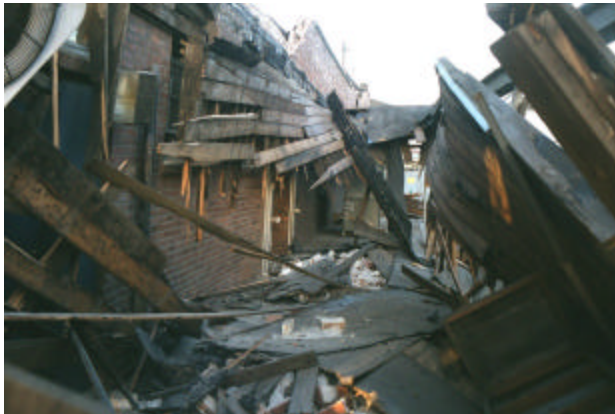
concrete or block walls from the rest of the structure. However, some wood frame commercial structures sustained significant damage, in downtown Seattle (Figure 4.6) as well as other places in the Puget Sound area. Landslides caused severe damage to wood frame buildings in Burien, as well as to timber houses resting on long timber piles built on the shore at Salmon Beach in Tacoma. One house at Salmon Beach collapsed into the sea.

Figure 4.6: Wood Frame Structure – Seattle Chocolates Building

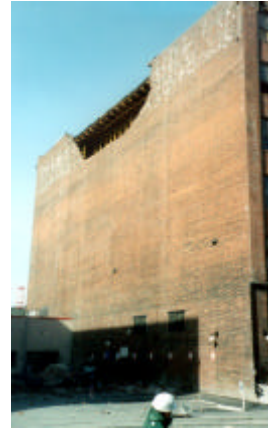
A six-story URM structure in Seattle was retrofitted by epoxy grouting the walls back to the slabs of the bottom two stories. The other floors were unoccupied. Brick was shed from the wall in only the top story, as shown in Figure 4.7.

Figure 4.7: Brick Wall Damage to Retrofitted Building

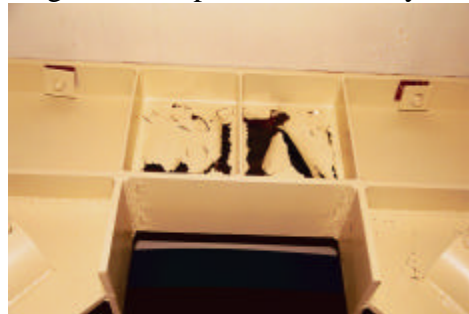
A nine-story URM, flat-slab-column building was retrofitted with steel frames, using a “life-safety” criterion, in order to protect the structure against collapse. Eccentrically braced chevron frames (EBFs) had been installed on the 3rd and 6th floors, with concentrically braced frames on the other floors. The EBFs showed paint flaking at the links that indicated yielding (Figure 4.8) in the east-west direction, but not in the north-south direction. No yielding was observed in the concentrically braced frames on the 1st and 5th floors.

Figure 4.8: Paint Flaking at Link of EBF in Retrofitted Building

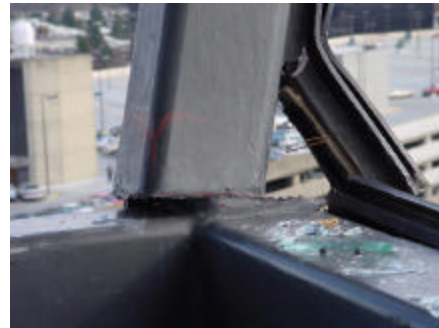
The control tower at SeaTac Airport sustained damage. In 1973, the tower had been raised and the lower 4 stories were seismically retrofitted with structural steel braces. No damage was seen in those stories. However, the welds failed in the eight 5-in. steel tube mullions supporting the heavy glass and the roof of the control tower (Figure 4.9). Nonstructural damage, described in Section 4.6, also occurred. The cost of repairing the tower is expected to exceed \$2 million.

Figure 4.9: SeaTac Control Tower Mullion Fracture

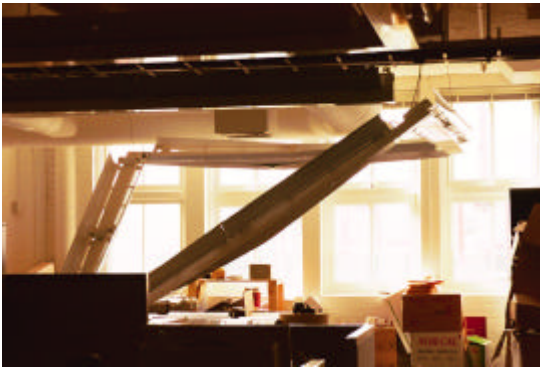
Figure 4.10: Damage to Ceilings and Light Fixtures

Damage to ceiling finishes included cracking in drywall, spalling of plaster, and damage to acoustical tile. Buildings at the Boeing campus sustained ceiling damage, damage to windows, and water damage, which resulted in an interruption of service. Fallen ceilings at a number of schools prompted temporary closure. 75 out of 96 Seattle schools reported some damage.

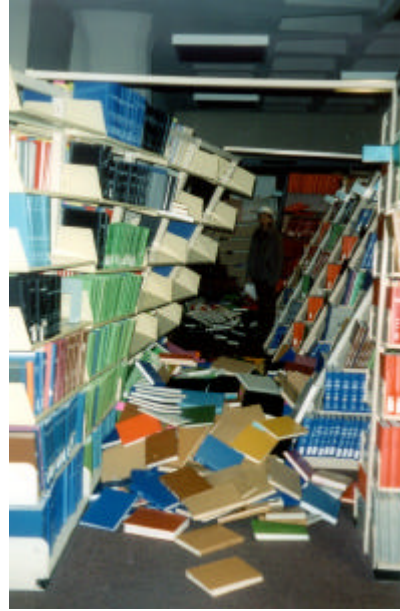
Damage to building contents was also widespread and problematic. Libraries as far north as the University of Washington (UW) were closed as a result of damage to bookracks (Figure 4.11). Large in-plane displacements of the racks were common. When implemented, bracing of the racks out-of-plane prevented displacements in that direction.

Figure 4.11: Bookshelf Damage and Loss of Shelf Contents, UW Engineering Library

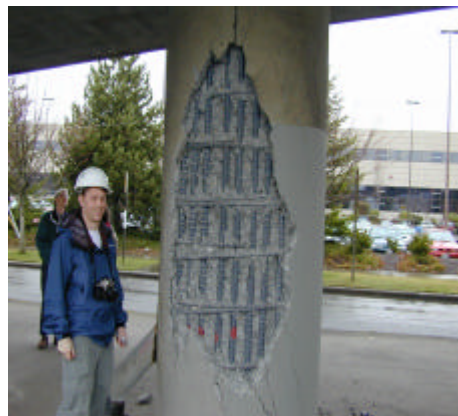
The shortest column, closest to the west abutment, failed in shear (Figure 5.1). During the earthquake, the cover spalled over the central half of the column height on the north and south sides. No signs of plastic hinging were observed at the

Figure 5.1: Shear Failure of Short Column of Holgate Ave. Overpass over I-5

top or bottom of the column. The column was permeated by diagonal cracks, indicating shear deformation in the east-west direction.

The failed circular column has a diameter of 4 feet and a clear height of 13 ft. It is reinforced longitudinally with #14 bars at 5-in. centers around the perimeter and #4 hoops at 12-in centers over the column height. The hoops have 24-in. laps.

The hypothesis of an east-west shear failure is supported by the abutment configuration and the damage observed to the bearings. At the abutment, 6-in. diameter steel roller bearings equipped with alignment pins allow nearly free motion in the longitudinal direction (east-west) so, in this direction, the short column was the stiffest support. The southernmost bearing experienced excessive longitudinal movement, causing the pins to come out of their sockets. In the transverse (north-south) direction, the relatively stiff west abutment appeared to have protected the column from large deformation demands.

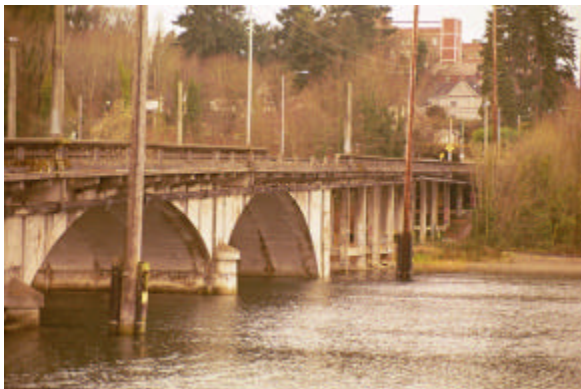
The 4th Avenue Bridge (Fig. 5.2) in Olympia consists of three spans of arches and approximately fifteen spans of reinforced concrete frames. It was constructed in 1920 and retrofitted after the 1949 Earthquake. Even before the 2001 earthquake, this bridge had significant cracking and spalling, and had been scheduled for replacement.

Figure 5.2: Collapsed Railing on 4th Avenue Bridge

Other than partial collapse of the concrete bridge railings on both sides of the bridge during the earthquake, the arch spans suffered little new damage. The reinforced concrete frames sustained much heavier damage. The tallest columns (nearest the arches) spalled near the bottom of the top flare, and cracks appear to have widened in beams near the ground level. The most potentially catastrophic damage was the formation of shear cracks near the corbels at the top of some of the shorter columns (Fig. 5.3).

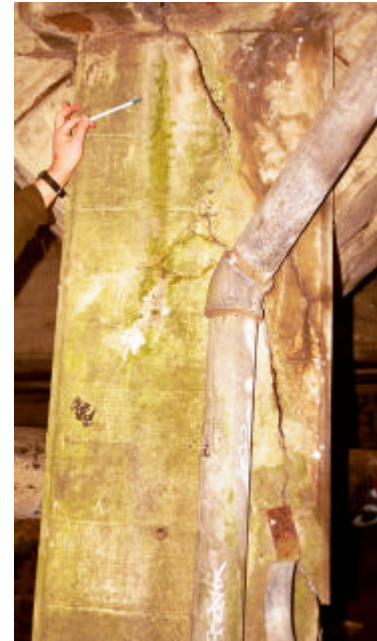
Figure 5.3: Shear Crack at Top of Column of 4th Ave. Bridge

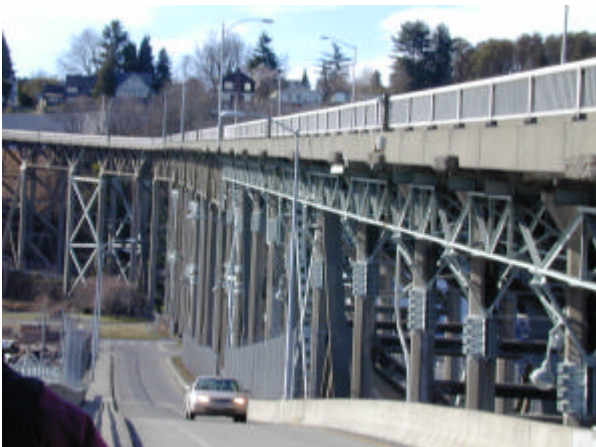
The Magnolia Viaduct carries traffic from the residential district of Magnolia, over Piers 90 and 91 of the Port of Seattle, to Elliott Avenue West. Before the earthquake, the structure carried an average daily traffic of 18,000 vehicles per day. The bridge was severely damaged during the earthquake and was closed immediately.

Figure 5.4: Magnolia Viaduct

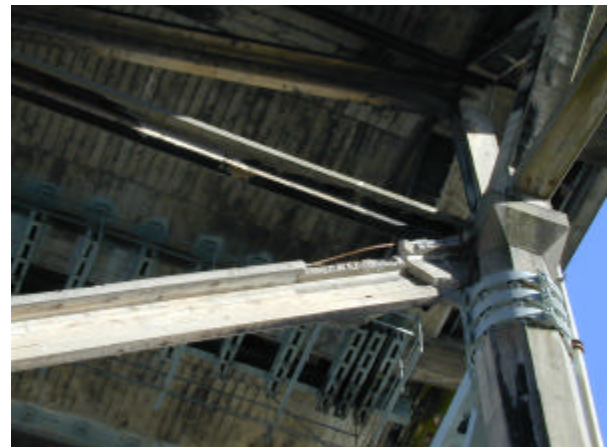
The majority of the damage occurred in the transverse reinforced concrete braces. All the diagonal members slope upwards towards the south. Since they likely have different properties in tension and compression, the structural system should be expected to have an asymmetrical response. The bars in many of the braces yielded in tension, and when the load was reverse, they buckled in compression. The widely spaced transverse reinforcement facilitated buckling. Many bars exhibit significant corrosion, some are smooth round bars (even in the primary reinforcement) and all have scant transverse tie steel. The corrosion has led to loss of cover over extensive regions of the members, resulting in main bars that are now exposed and unsupported.

Figure 5.5: Damaged Brace in Viaduct

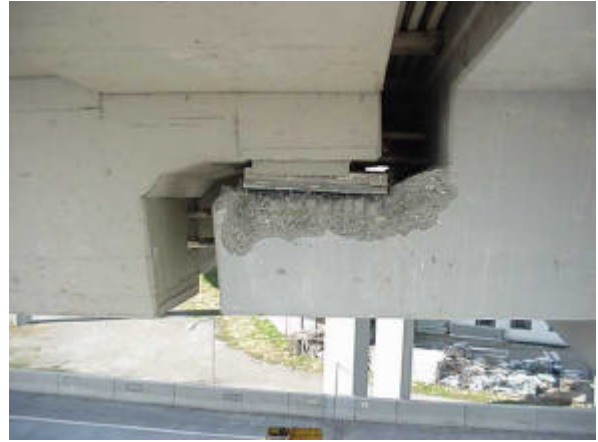
As shown in Figure 5.6, damage to this joint consisted of spalling of concrete on the north and south top corners of the bearing seat, which exposed some reinforcement. Bearing seat damage resulted from transverse shear forces, which failed the studs that connected the masonry plate to the concrete seat. The failure of this detail, which had been previously identified as vulnerable, led to closure of the bridge.

Figure 5.6: Joint Damage to Fourth Ave. Onramp

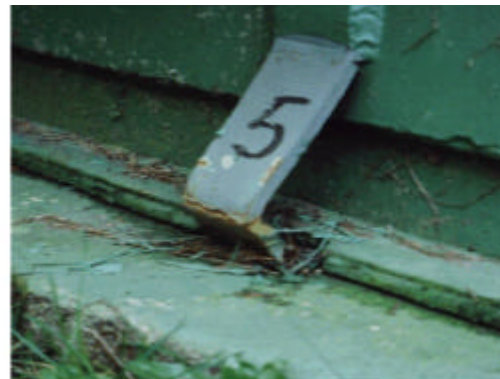
Steel standpipe anchorages fractured (Figure 6.1), and braces to elevated tanks were damaged in water systems in the Tacoma area and on the Kitsap Peninsula. In one case, a standpipe, designed to modern AWWA standards, suffered anchor bolt damage.

Figure 6.1. Broken anchor strap on 450,000-gallon water standpipe.

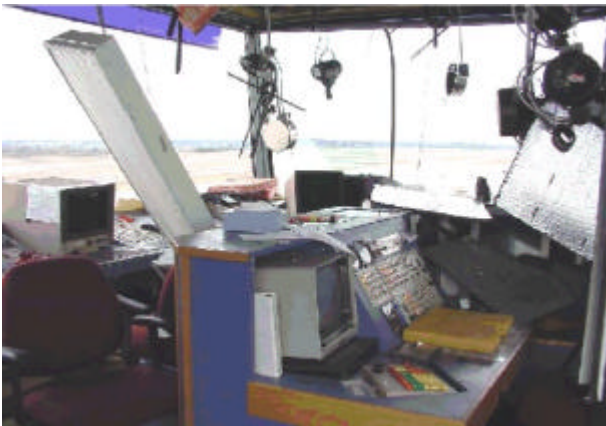
Earthquake damage significantly restricted air transportation in the Puget Sound region. All windows but one in the SeaTac Airport control tower broke (Figure 6.2). Currently, controllers are using a portable control tower with the result that capacity is limited to 24 flights per hour, down from the normal 40 per hour. Airport control towers are particularly vulnerable to seismic forces, because the need to have a nearly unobstructed 360-degree view limits the extent of the structural support that can be provided.

Figure 6.2. SeaTac Airport Control Tower Showing Broken Glass and Light Fixture Hanging from the Ceiling
